Storm Damage Report

Brabo International 11909 Auburn Road Laredo, TX 78045

FIELD REPORT FOR INITIAL STORM DAMAGE INVESTIGATION

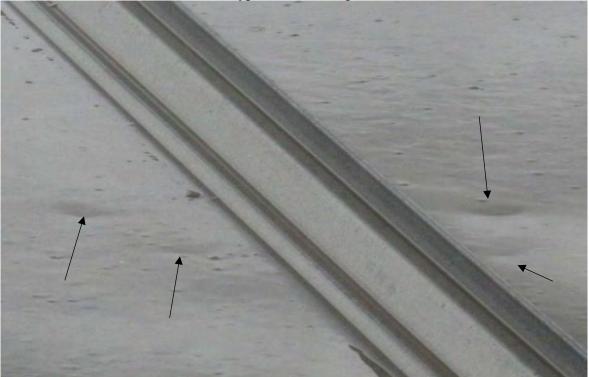
Large hail impact marks

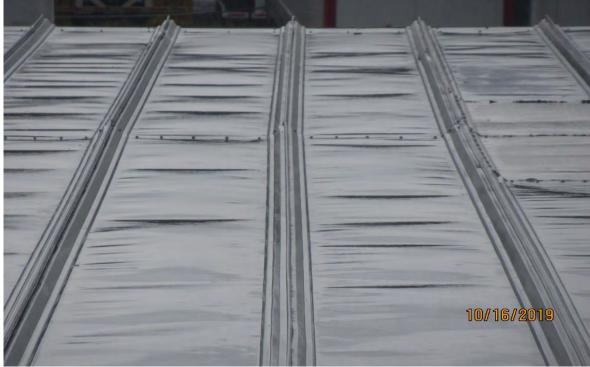
Typical panel distortion and wind uplift overview

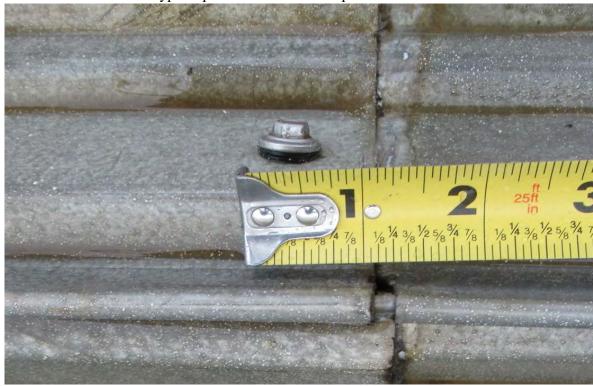
Panel distortion and bent fastener

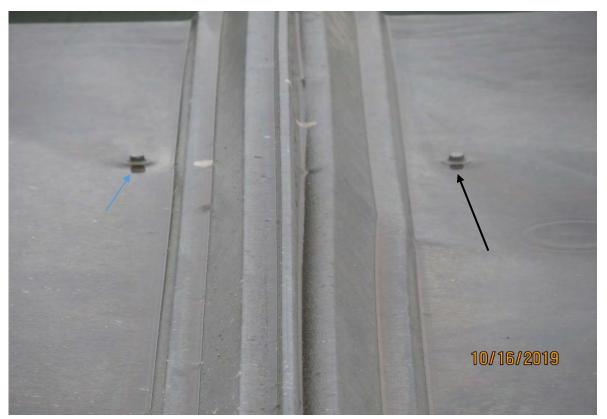
Panel pulled apart at joint with uplift at fasteners

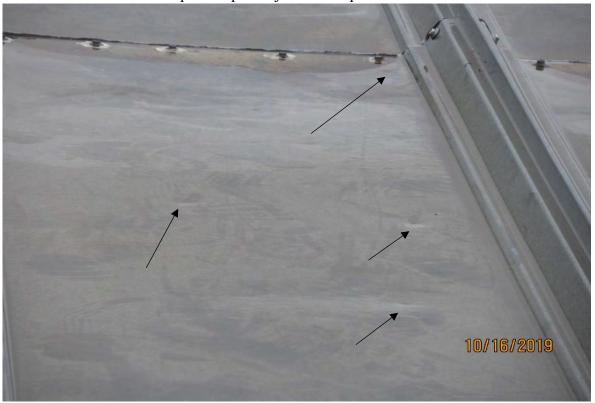
Hail damage and panel uplift
